SUMMARY OF HYDRAULIC MODEL TESTS

HYD-332

HEART BUTTE DAM
Spillway and Outlet Works Model, Scale 1:21.5

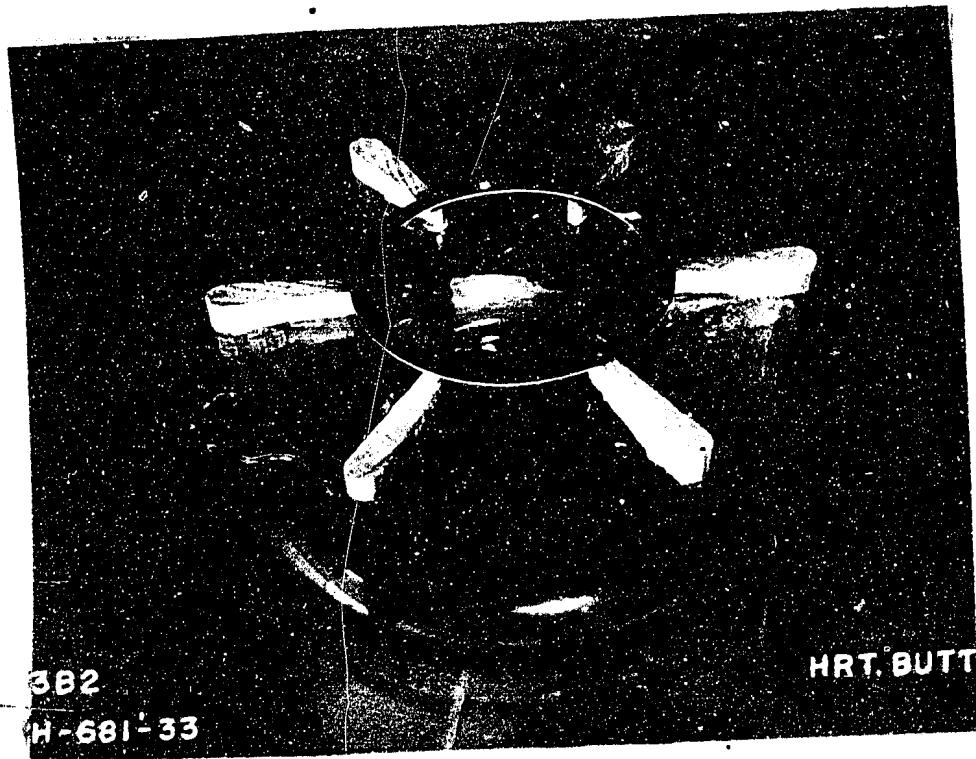
FIGURE 3

B--Six piers placed radially on the crest reduced the vortex to negligible size.

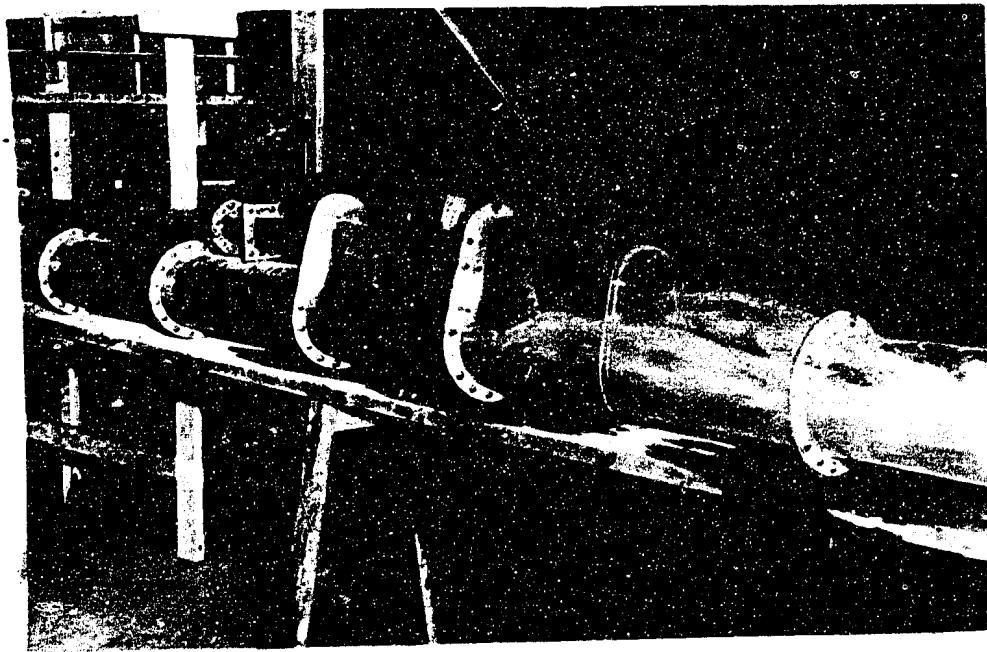
B--A considerably longer junction section was tested. Smoother flow resulted but the improvement did not justify the extra cost.

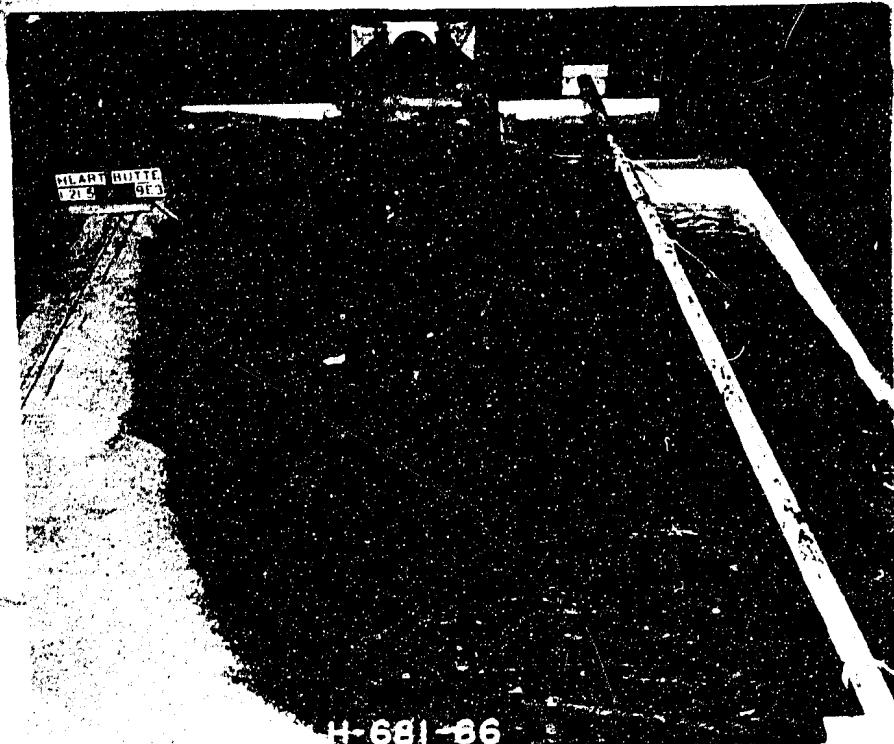
A--The recommended basin, shown in operation, was reduced to minimum dimensions consistent with acceptable performance.

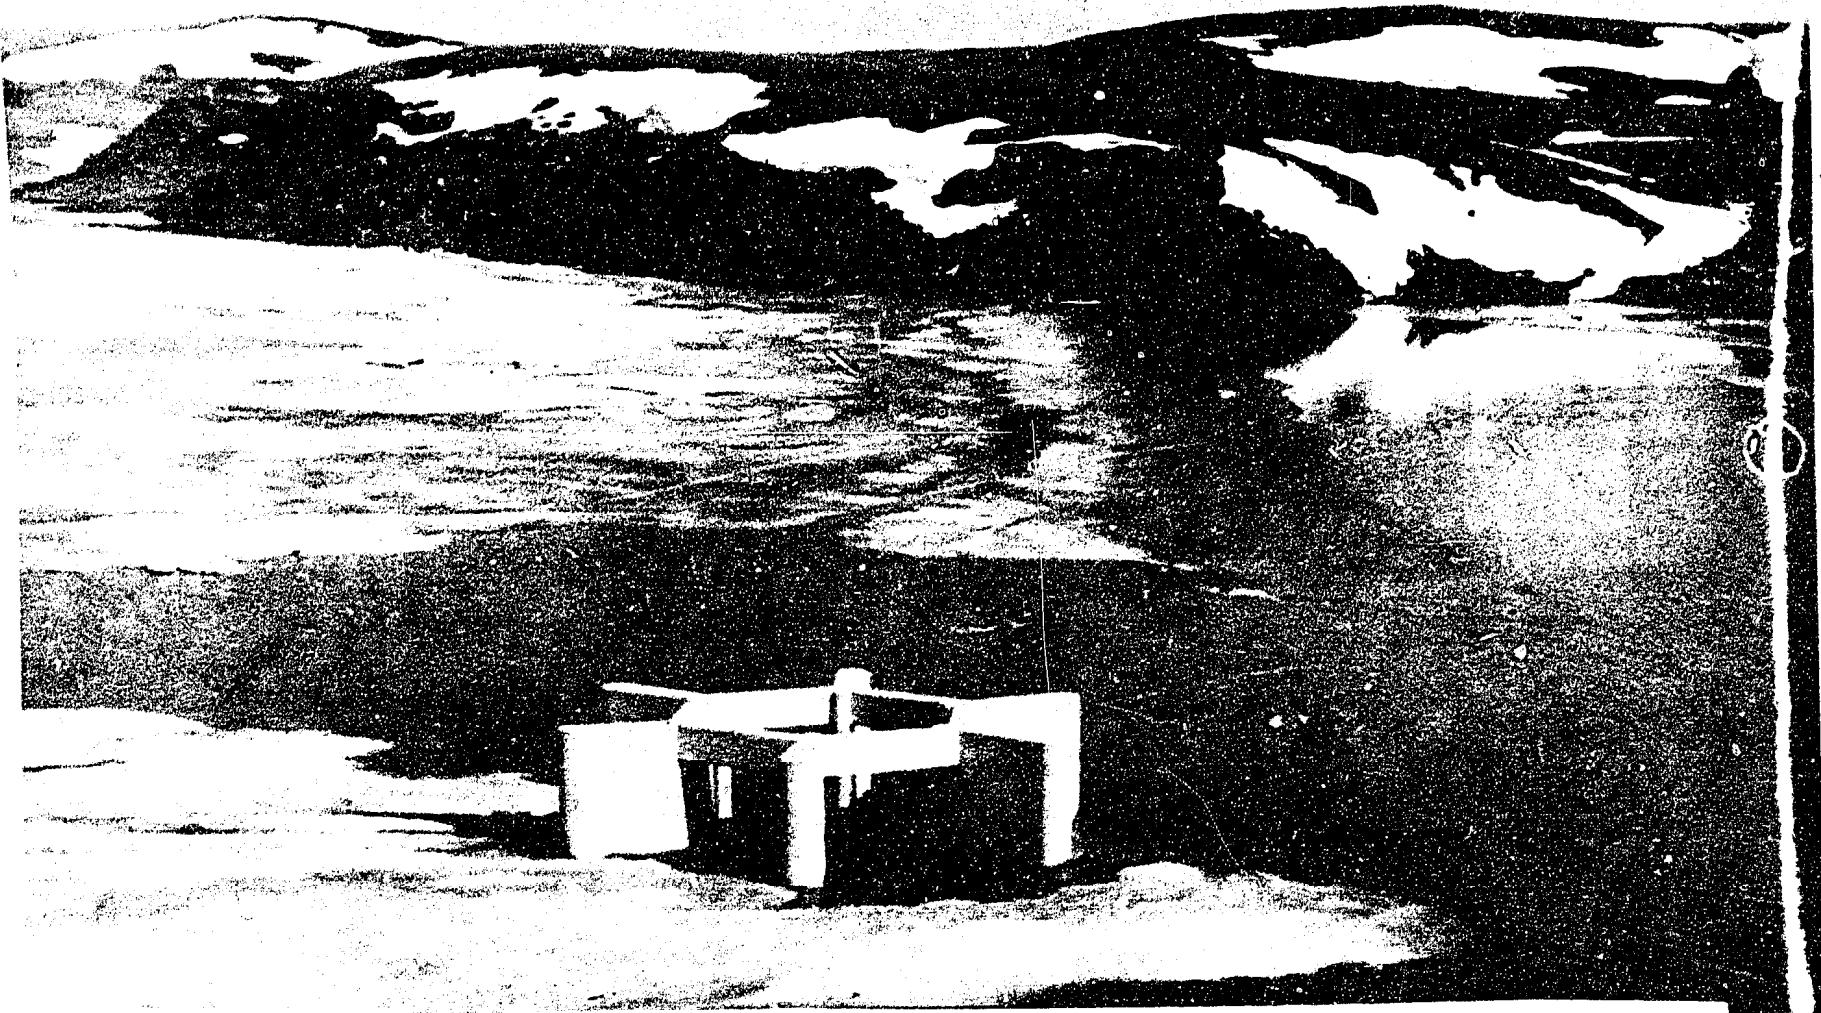
Figure 16

On April 17 the reservoir had risen sufficiently to submerge the spillway crest. Some of the ice was discharged through the spillway but the wind had moved some of the ice upstream. Reservoir elevation 2073.8, head on crest 9.3 feet.

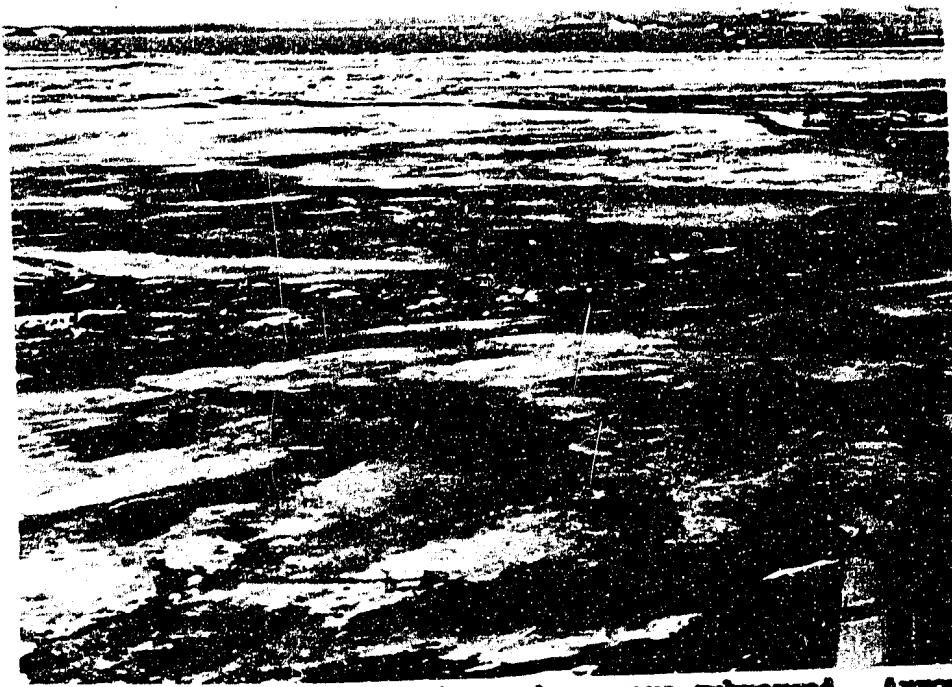
A--On April 18 the spillway piers were submerged. Arrow indicates spillway location. Very slight motion on water surface beneath the arrow was noted. Reservoir elevation 2080.2, head on crest 15.7 feet, piers submerged 1.7 feet, discharge 3,650 cfs.

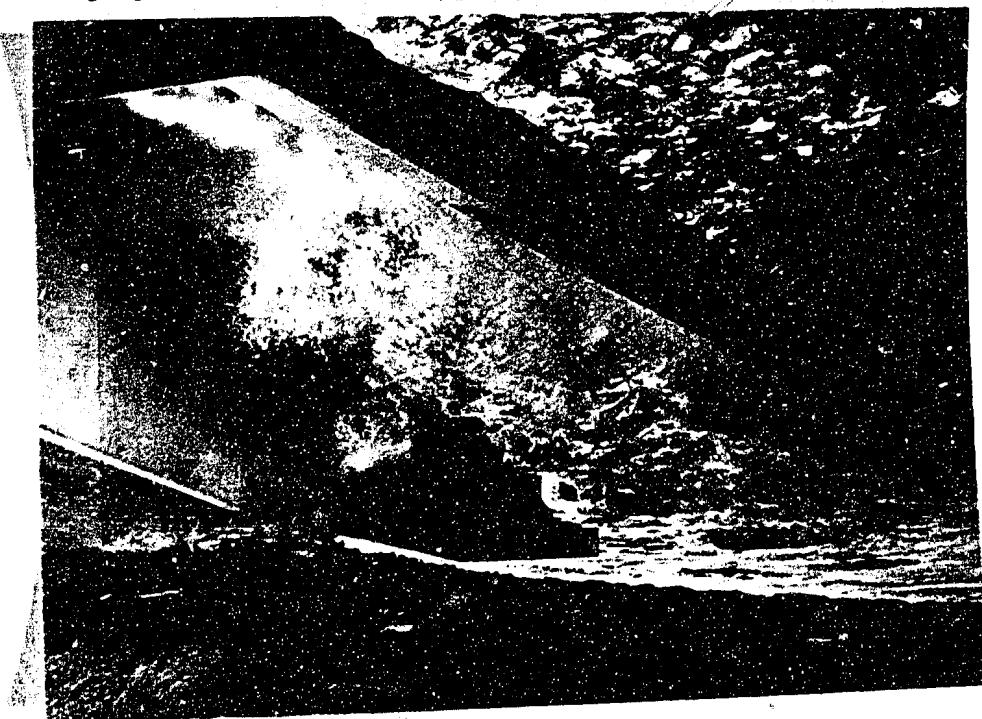
A--After entering the basin was well sorted and
well distributed across the basin width.

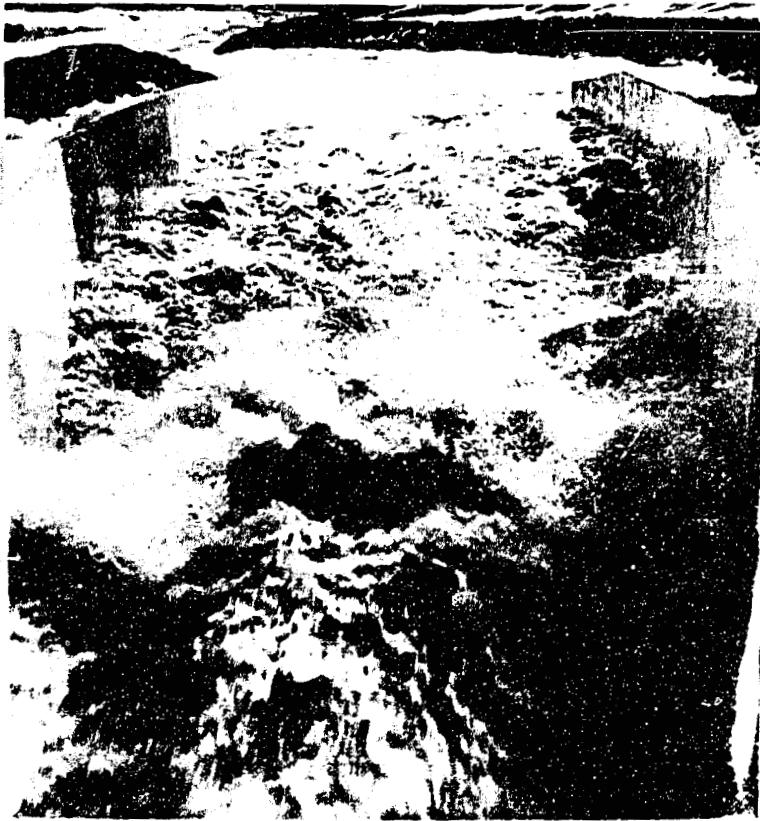
A--Flow from the tunnel was spread to the entire basin width by the dividing walls, which, for this discharge, are submerged.

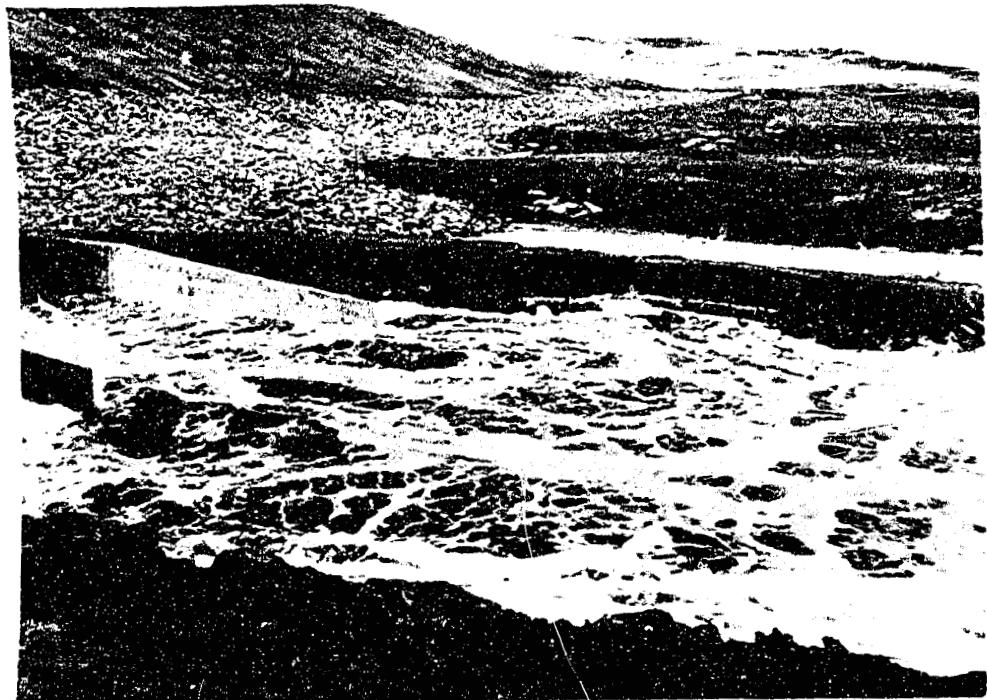
B--Flow leaving the basin had no choppy waves but did have mild swells and boils.

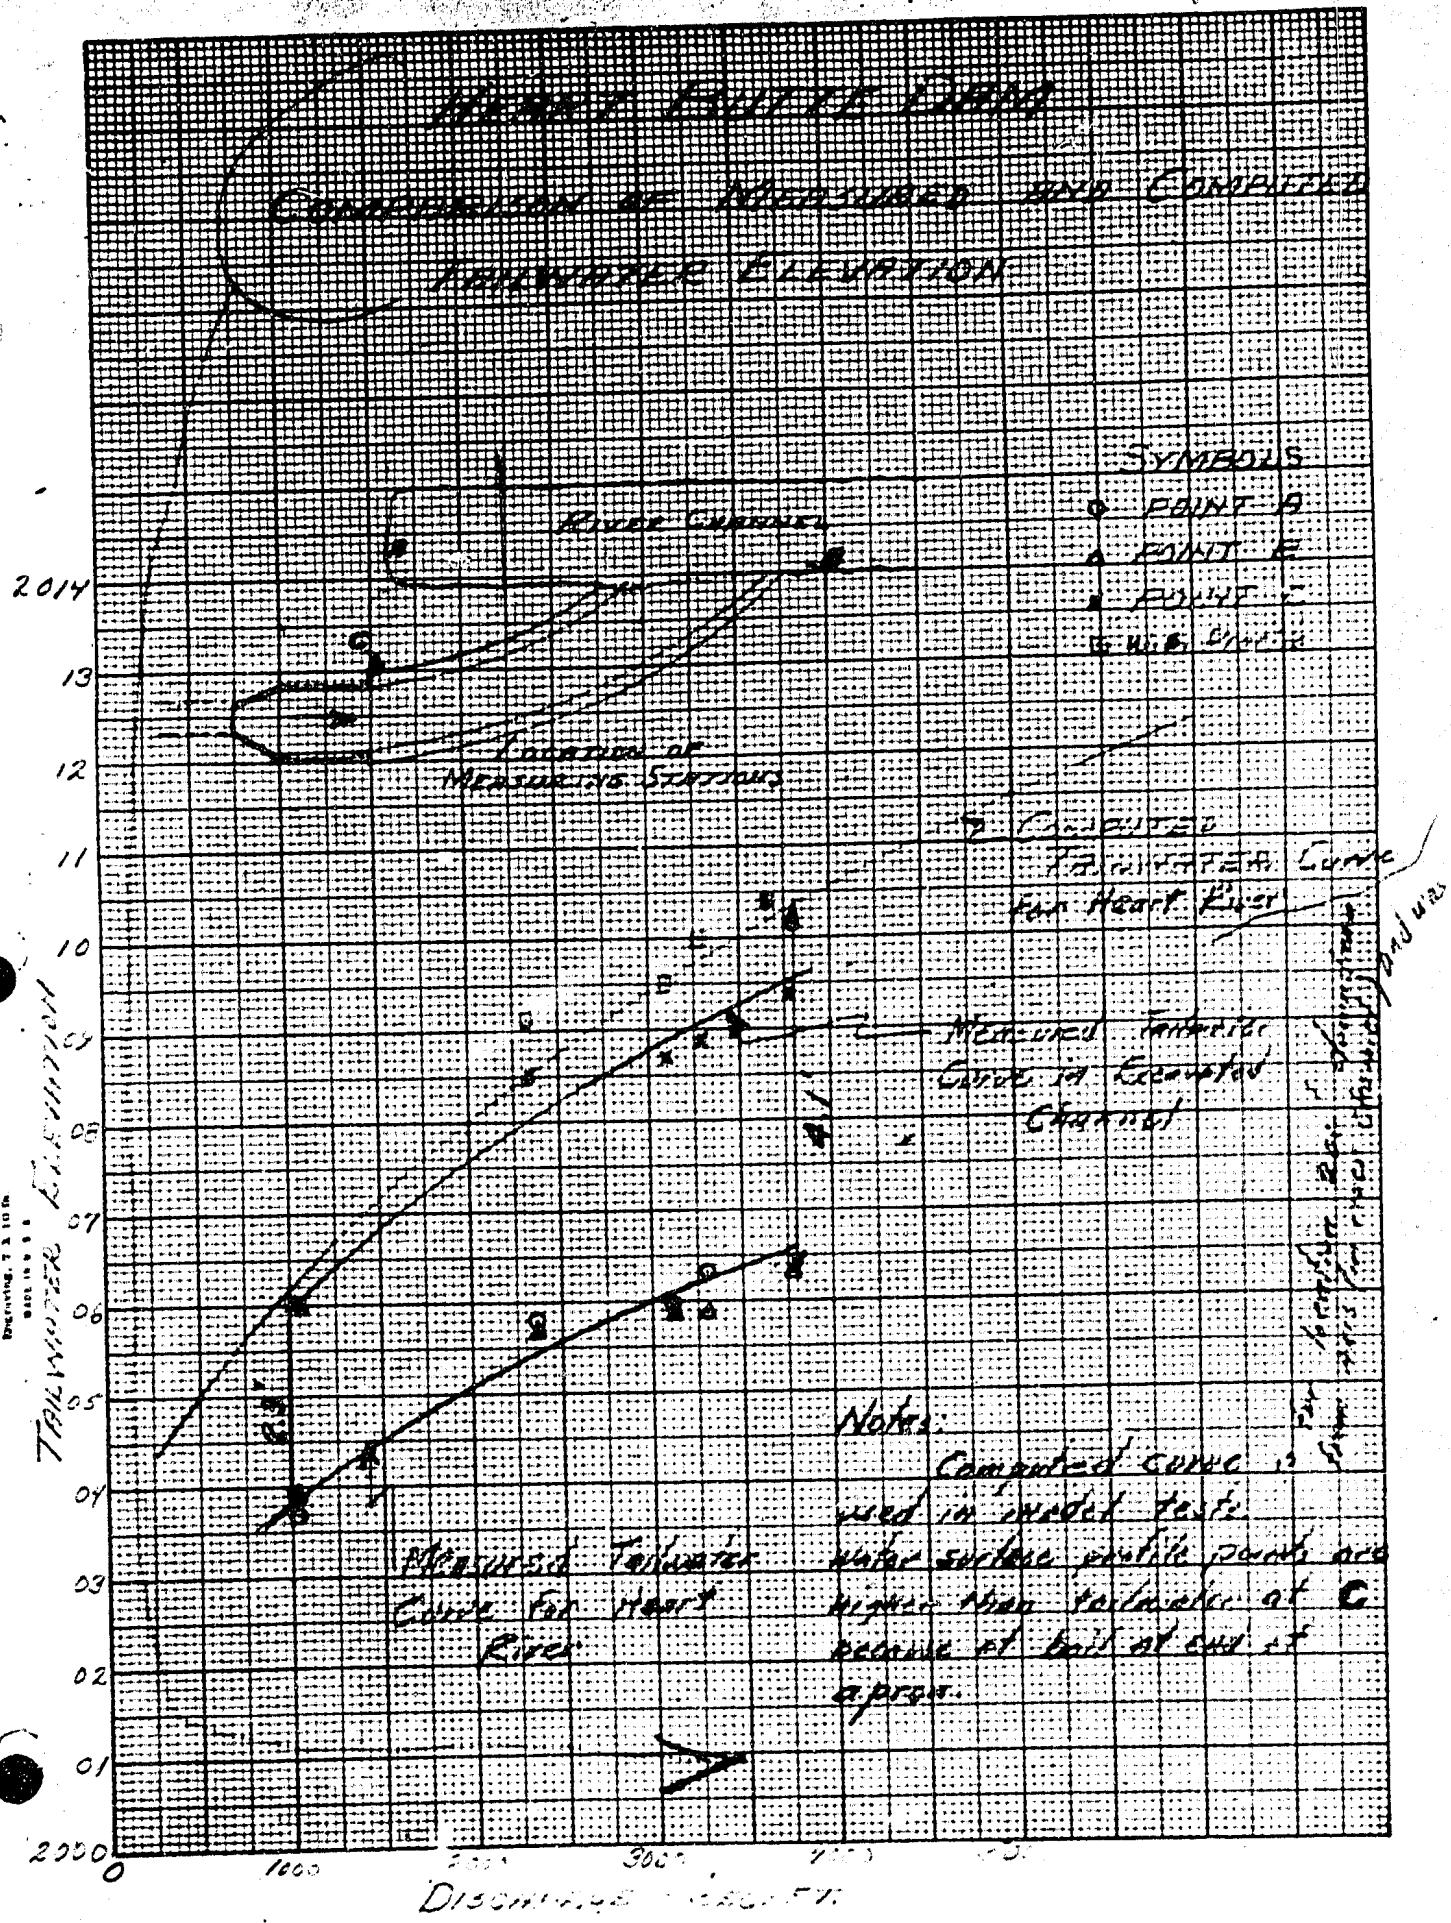
FIG 31

W.F. Levels were run, consequently, to determine the tail-water elevation at four separated points for five different discharges. The location of these points, together with the tail-water elevation and discharge are shown in Figure 31, plotted below the tail-water curve used in the model tests. These data show the computed tail-water curve to be 2.3 feet higher at 1,000 second feet and 4.1 feet higher at 3,600 second feet than the actual measured curve in the Heart River. Tail-water elevations measured in the excavated channel more nearly coincided with the computed curve, but at 3,600 second feet the elevation at Point C, Figure 31, taken in a quiet area adjacent to the wing wall at the end of the apron, was 1 foot below the computed curve. Elevations obtained from water-surface profiles taken along the basin centerline agreed with the computed curve, but only because they included the boil height at the end of the apron which was slightly higher than the adjacent tail water.
